HUDSON RIVER BASIN
CLOVE BROOK, SUSSEX COUNTY
NEW JERSEY

LEVEL
CLOVE RIVER DAM
NJ 00035

PHASE 1 INSPECTION REPORT
NATIONAL DAM SAFETY PROGRAM

Clove River Dam (NJ-00035). Hudson River
Basin, Clove Brook, Sussex County,
New Jersey. Phase I Inspection report.

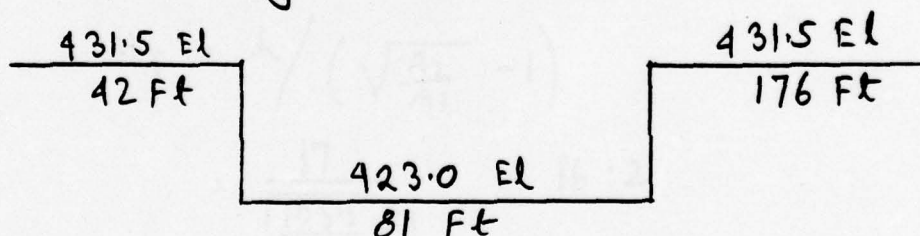
Spillway and Dam

The low level outlet is a 3' x 3' Conduit - leading to a 48" x 36" vich outlet. The sluice gate is not operable due to long standing neglect. However a drawdown calculation is made at the end.

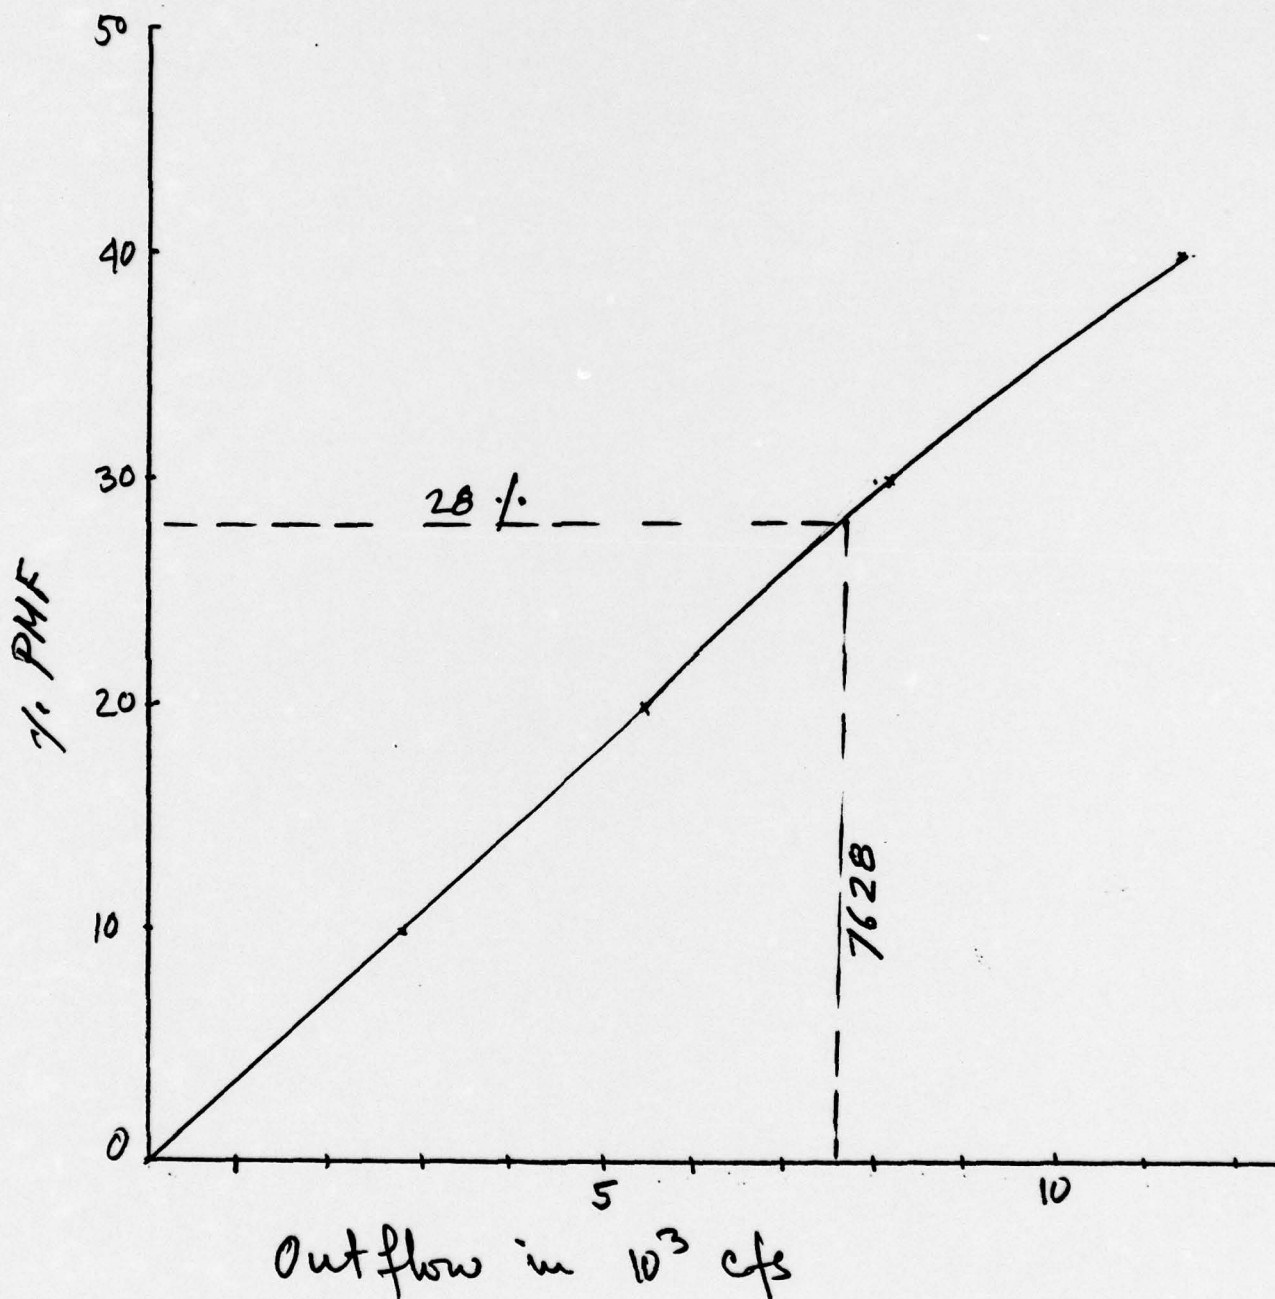
Overtopping Potential

Overtopping of Dam occurs at EL 431.5
 $Q = 7628$ (28% of PMF)

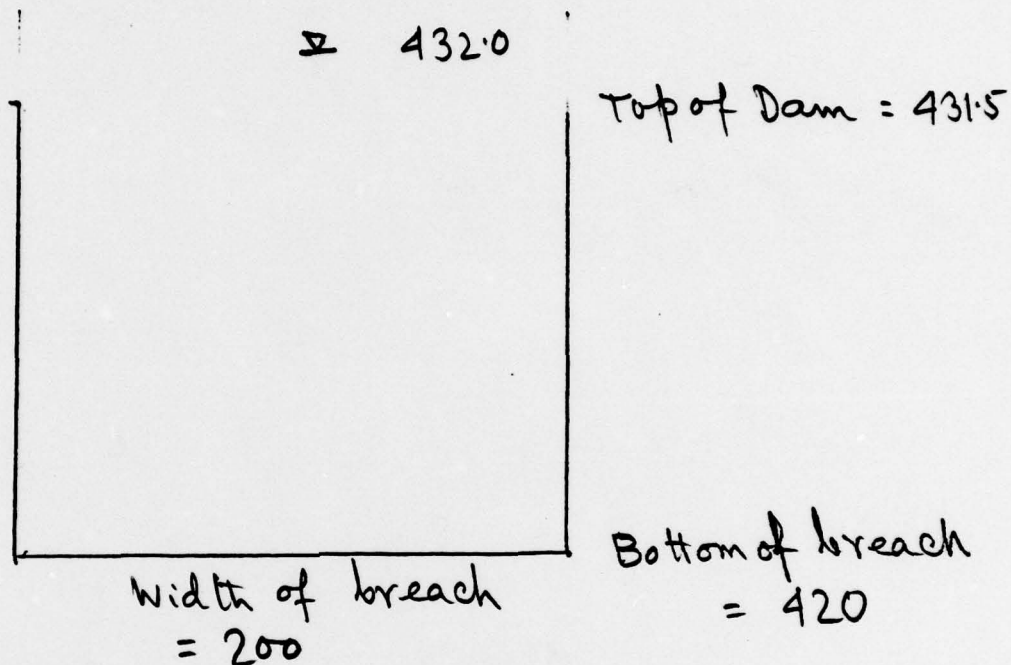
Breach Analysis

Assume breach begins to develop when reservoir stage reaches just above the Dam. Assumed elevation 432 u, 0.5 ft above the dam

Effect of breach was analysed 1,600 ft D/S of Dam

Max. W.S EL without Dam Break = 410.0
